# Twin Oaks Villas – Lagoon Slopes

## Geotechnical Exploration Report

July 5, 2024 | Terracon Project No. ES245149

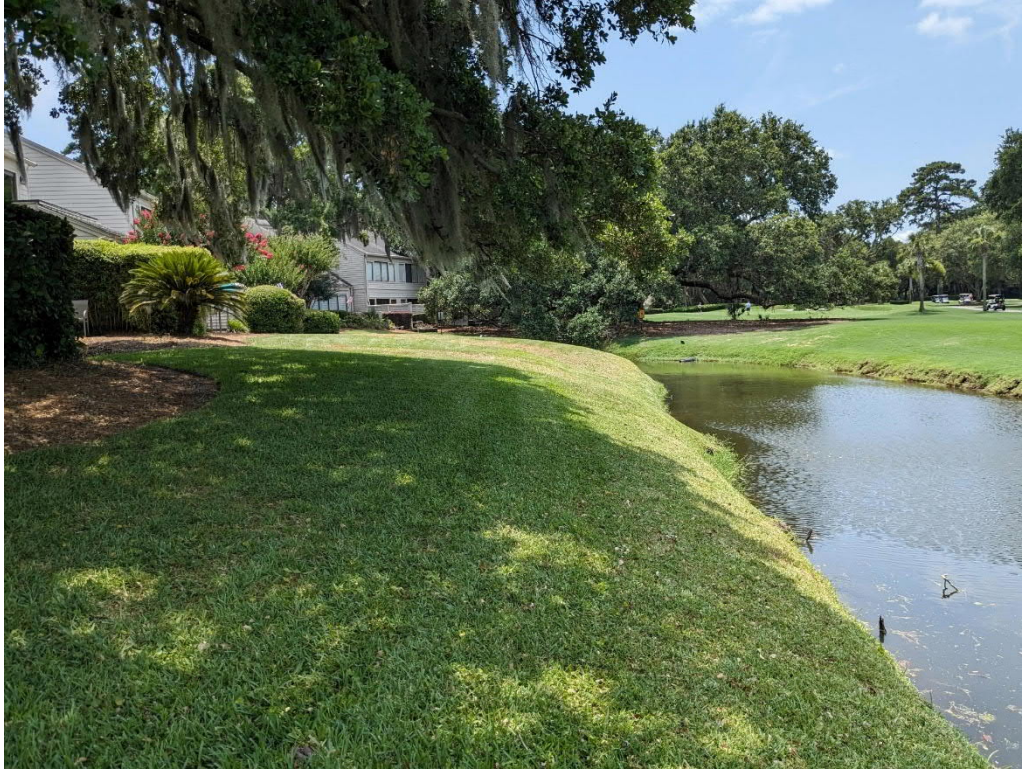
We visited the site to observe the slope conditions behind villas 181-185, 186-190, and 191-195. The slopes appeared generally intact and stable. No observable erosion along the lagoon/slope interface was noted during our site visit.

Photo 1: Slope behind Villas 181-185

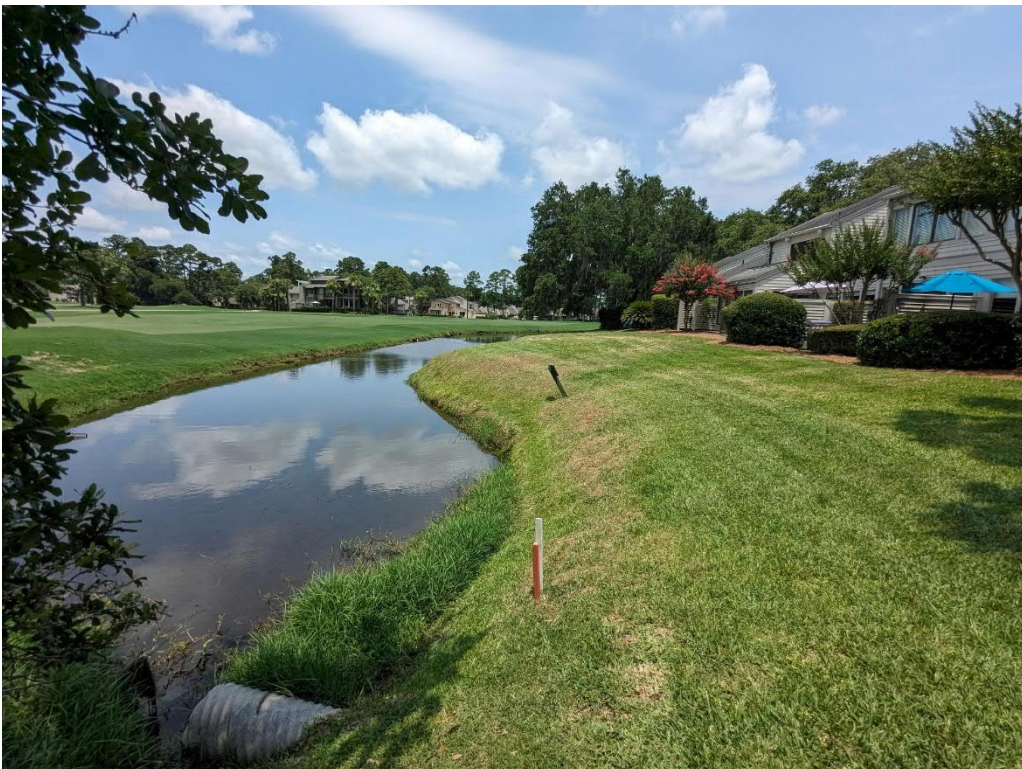
Photo 2: Slope behind Villas 181-185

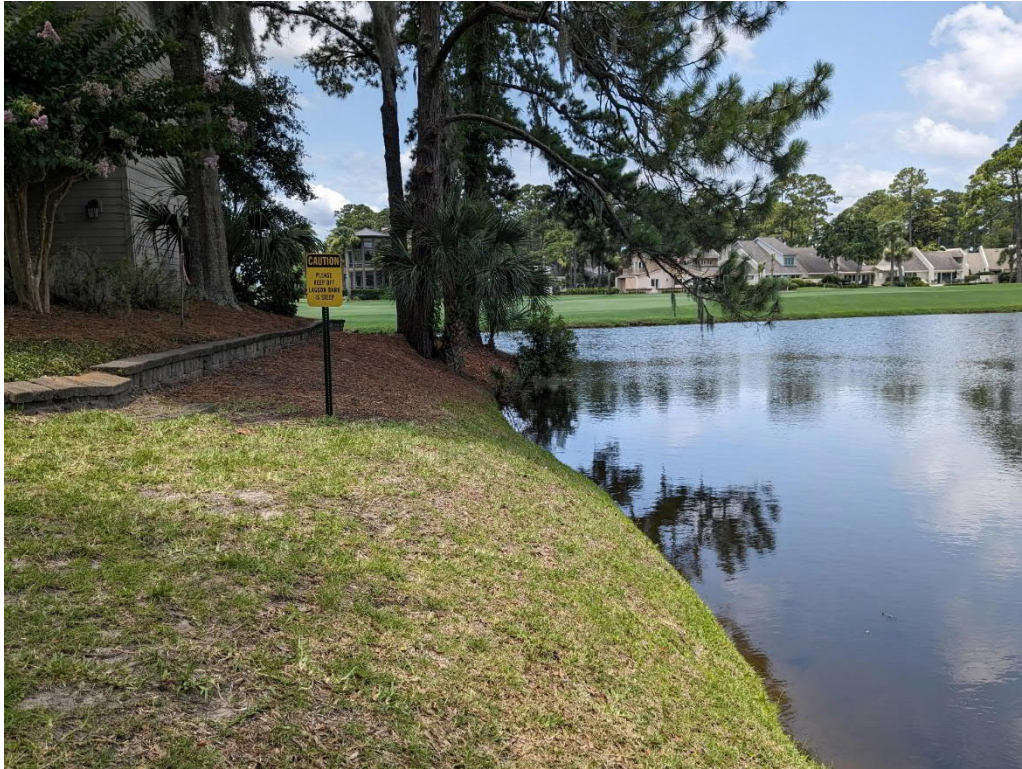
Photo 3: Slope beside Villas 186-190

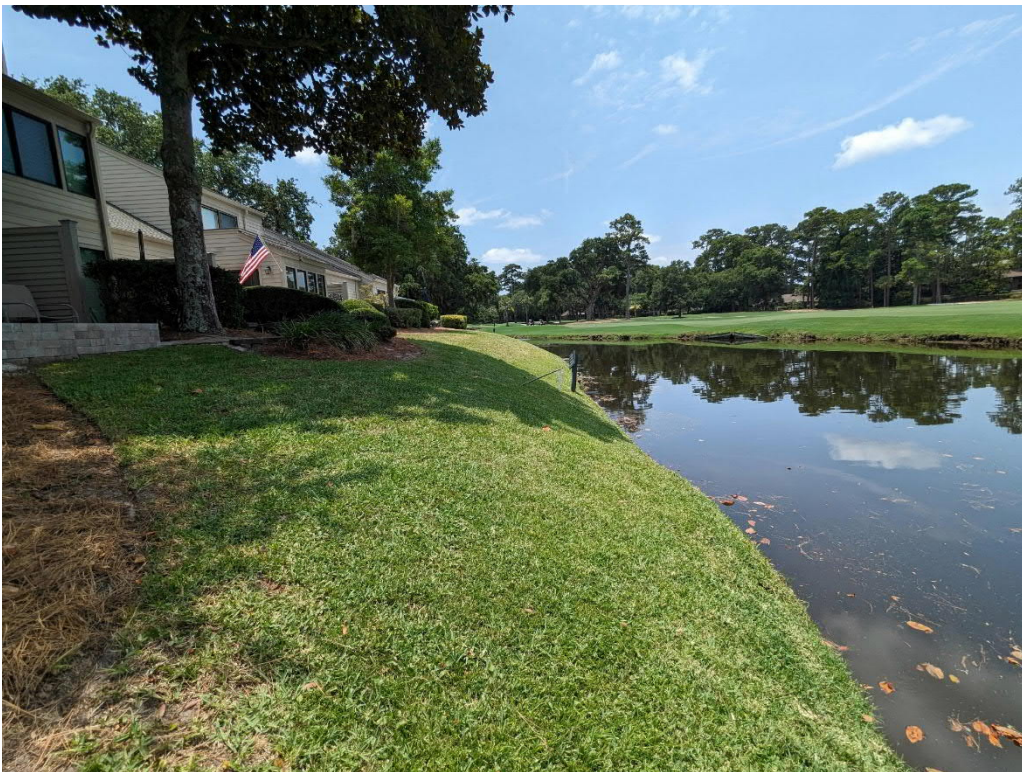
Photo 4: Slope behind Villas 186-190

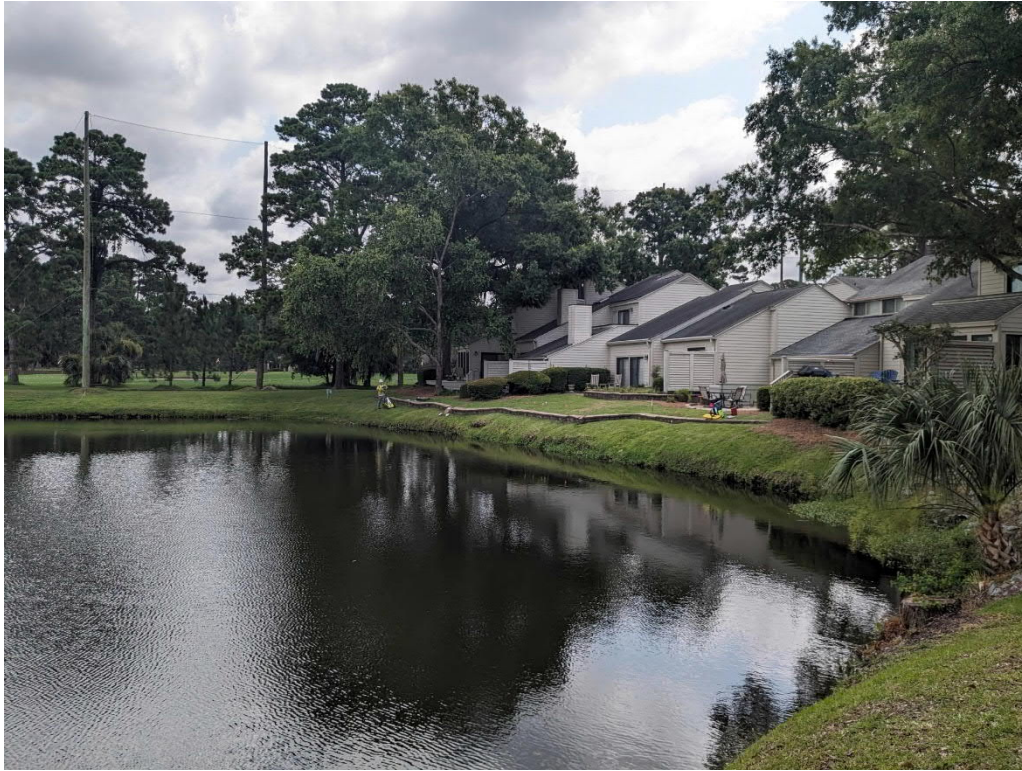
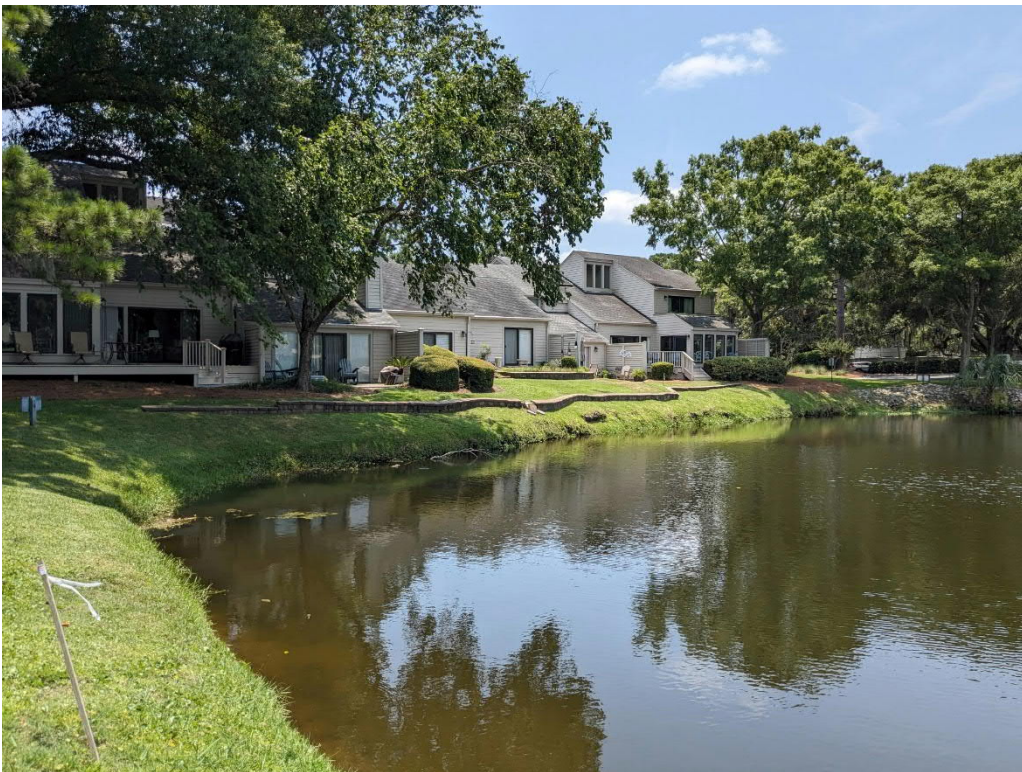
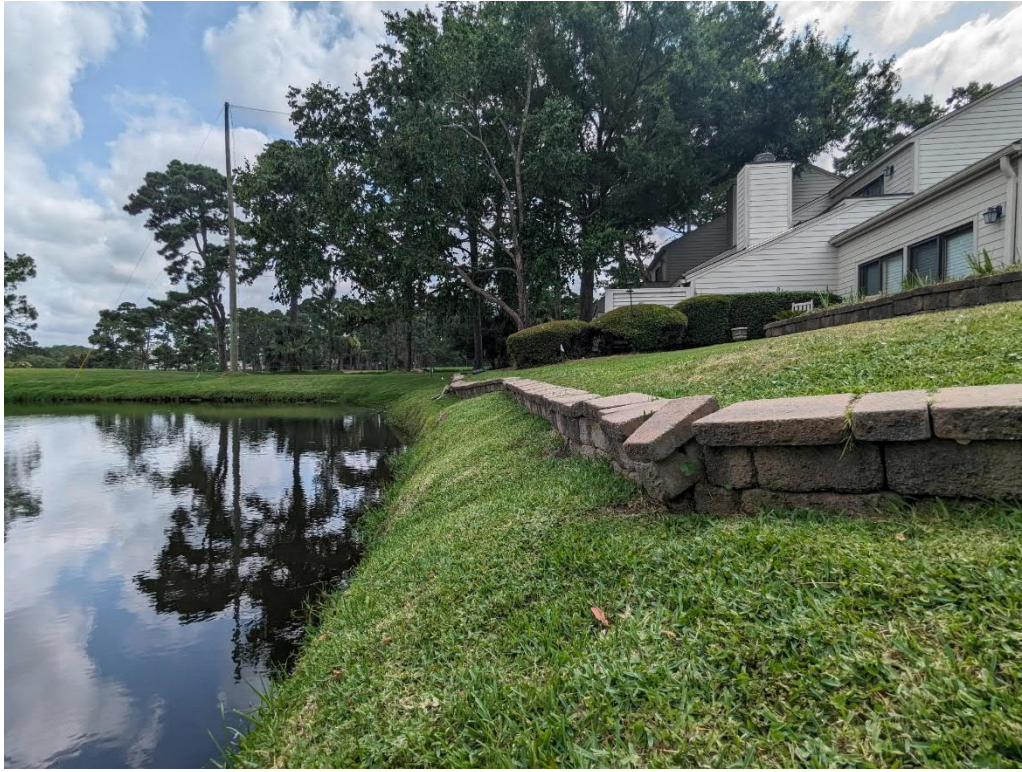
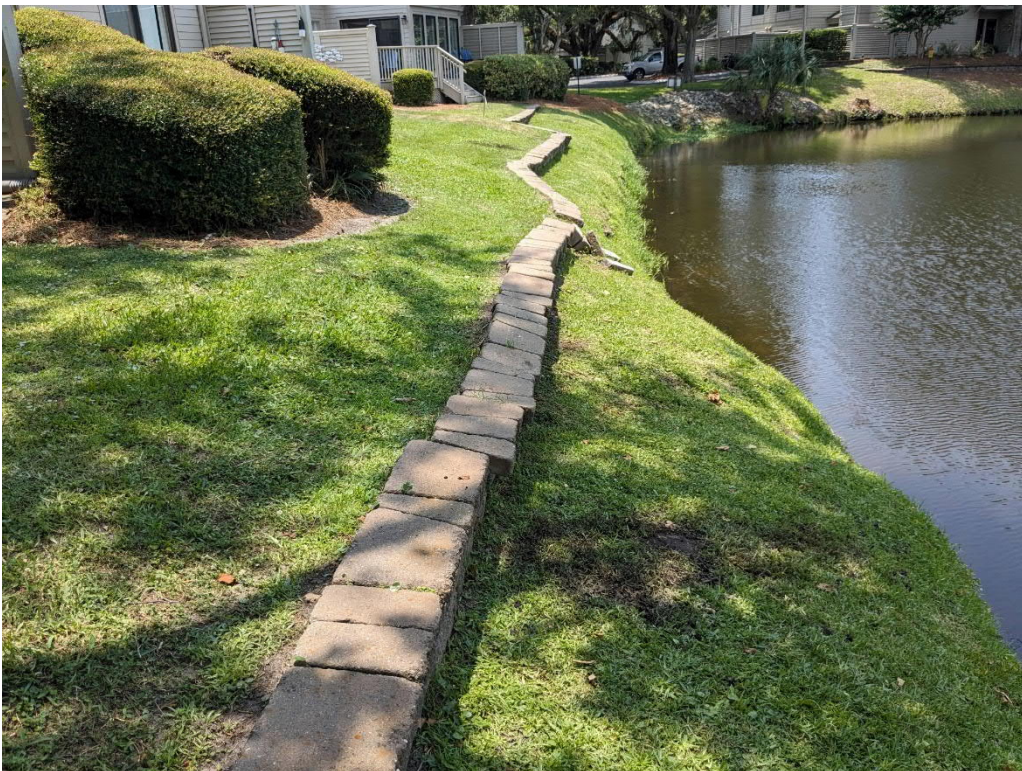
The landscape block wall in the slope behind villas 191-195 had some observable damage and deformation. There were also signs of localized erosion around roof drain discharge pop-ups behind the block wall.

The existing landscape block wall behind Villas 191-195 was observed to not be integral to the overall stability of the slope and can be removed. The observed deformation of the wall face could have been caused multiple factors, including quality of wall construction, water and earth pressure acting on the wall, and insufficient base friction and passive resistance from soil in front of the wall.

Photo 5: Slope behind Villas 191-195

To reduce potential for future localized erosion on the slope surface from roof runoff of the villas, we recommend that the roof runoff drains connect to a lateral collector pipe running approximately parallel to the lagoon. The discharge points of the lateral pipe should be away from the slope face and discharge onto riprap or directly into the lagoon. If the block wall is removed, the lateral connector pipe could be installed in the opening left by the removed blocks.

Additionally, we recommend that grass and vegetation cover be maintained along the slope faces to reduce erosion potential of the sandy soils.
